Miata Tech Day with Randy Slagle at Triple R Autosports, May 11, 2013  
by Don McCann and Don Gervais

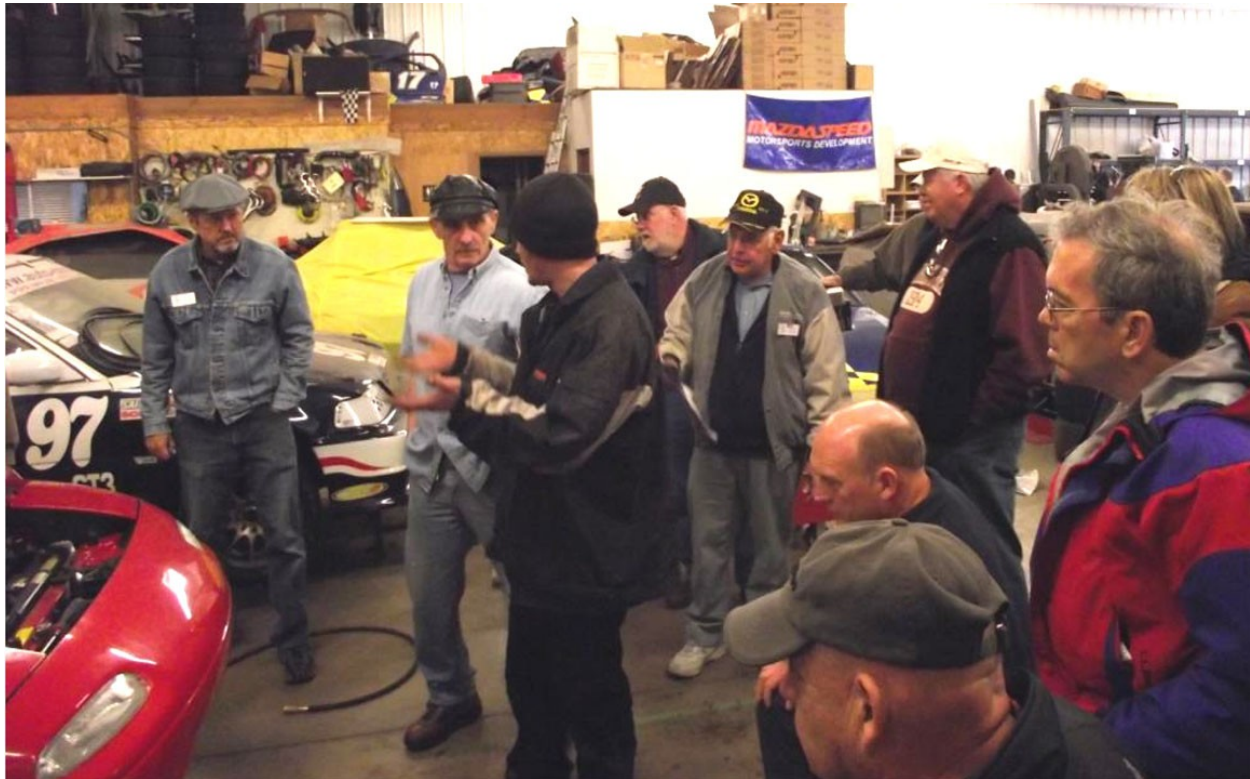
The first item was a flush of the cooling system on Tim Deadrick's 1990 Red Miata, which he purchased new in 1989; the car was in excellent condition. The front of the car was jacked up with the parking brake applied and the transmission in gear. Then we could to remove the radiator drain plug. The coolant was drained by slowly opening the radiator cap. This method will keep you from getting a coolant bath. The remainder of the coolant in the engine and heater core was removed with a vacuum device that was inserted in the radiator filler opening. The vacuum method must be used on 2006 NC models due to an expansion tank that can produce an air lock in the cylinder head if the classical method of draining coolant is used without vacuum. After about 20 minutes, with the system under vacuum, a hose from the device was placed in the new coolant solution, the vacuum was slowly reduced, and the new coolant was sucked into the radiator, engine and heater core. A job well done! This procedure can be used for checking leaks. If the vacuum decreases in a certain amount of time, there could be a leak somewhere in the cooling system.
